Restoring Freshwater Wetlands in the South Slough National Estuarine Research Reserve:

Links between water table elevation, soils, and plant communities in restored, altered, and undisturbed wetlands

December 2005

Prepared by:
Laura Brophy
Green Point Consulting
Corvallis, Oregon

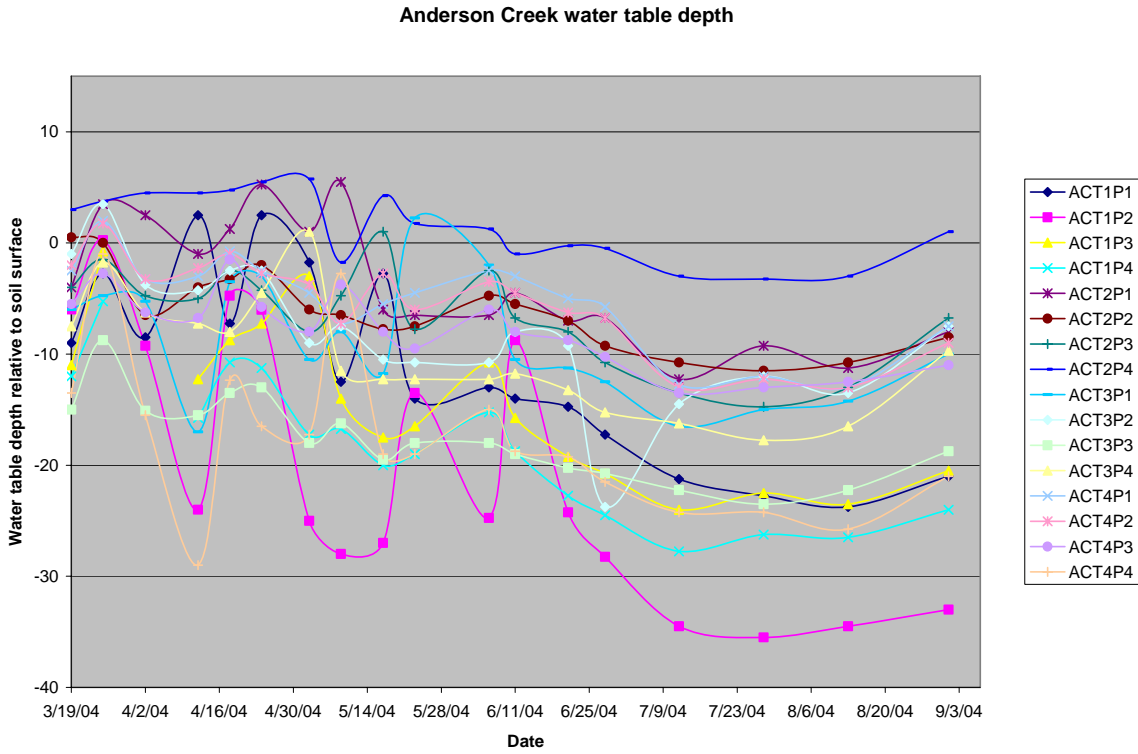
Figure 6. Water table dynamics at Anderson Creek.

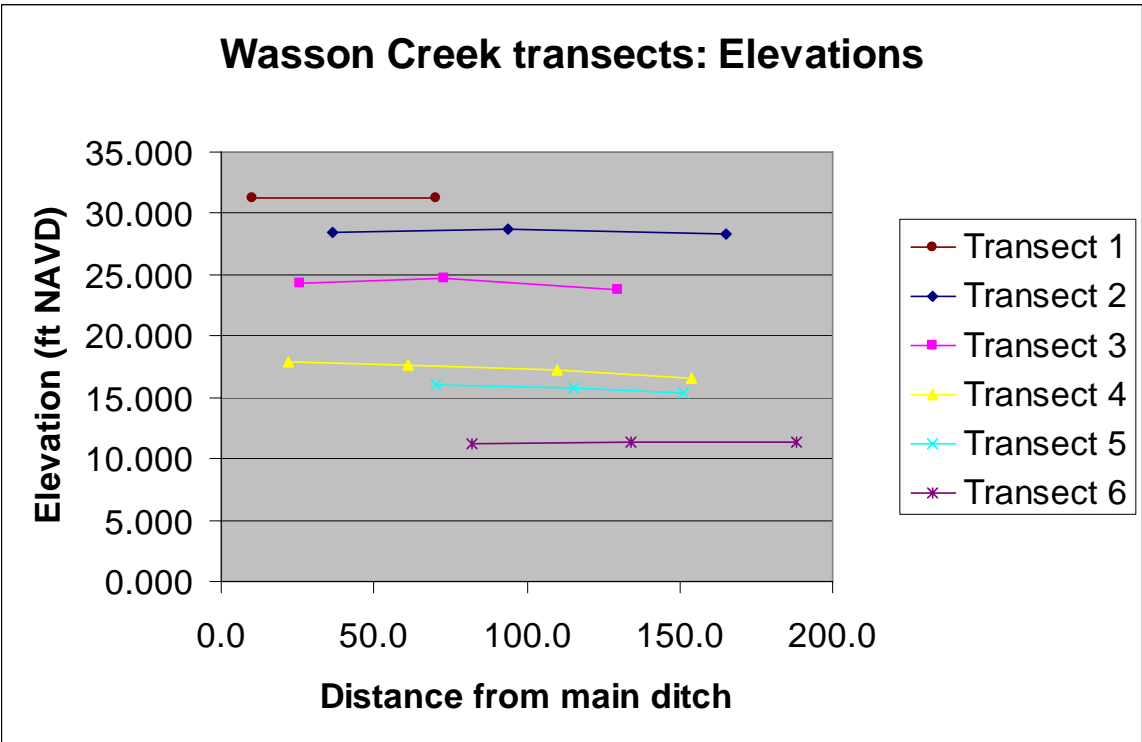
Figure 9. Elevation versus distance from main ditch, Wasson Creek transects. Sample points are shown as markers along each transect line.

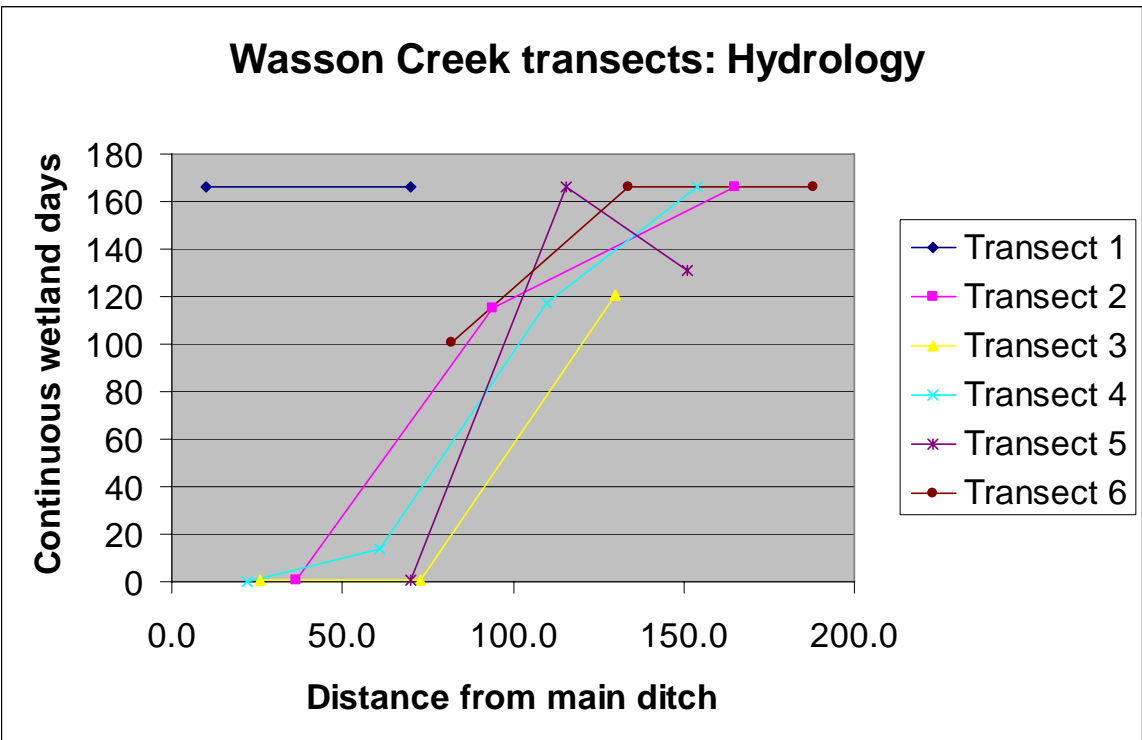
Figure 10. Duration of shallow water table ("Continuous wetland days") versus distance from channel, Wasson Creek transects. Sample points are shown as markers along each transect line.

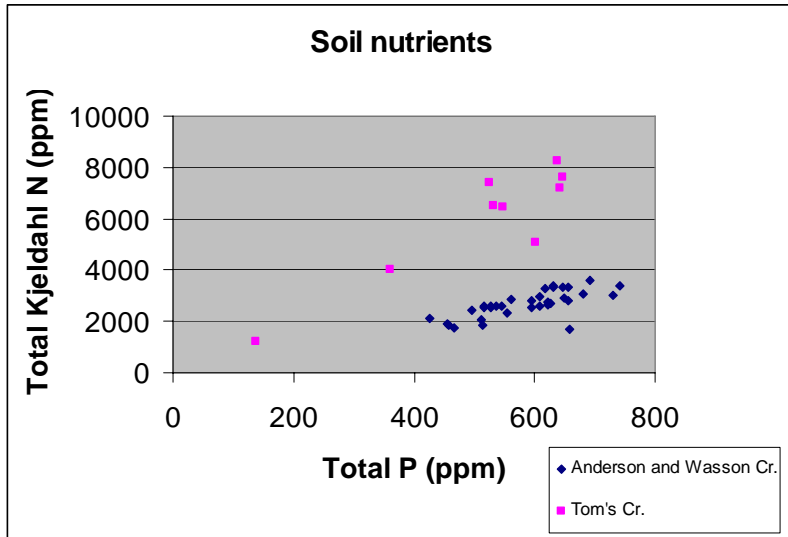
Figure 11. Soil nutrient relationships at study sites.

Total Kjeldahl N was closely correlated to total P at Anderson and Wasson Creeks ($R^2=0.53$, $p<0.01$), but not at Tom's Creek (Figure 11). Total Kjeldahl N was closely correlated with % OM at Anderson and Wasson ($R^2=0.35$, $p<0.01$) and at Tom's Creek ($R^2=0.51$, $p<0.05$). Kjeldahl N includes N found in undecomposed organic matter, which could explain this correlation.

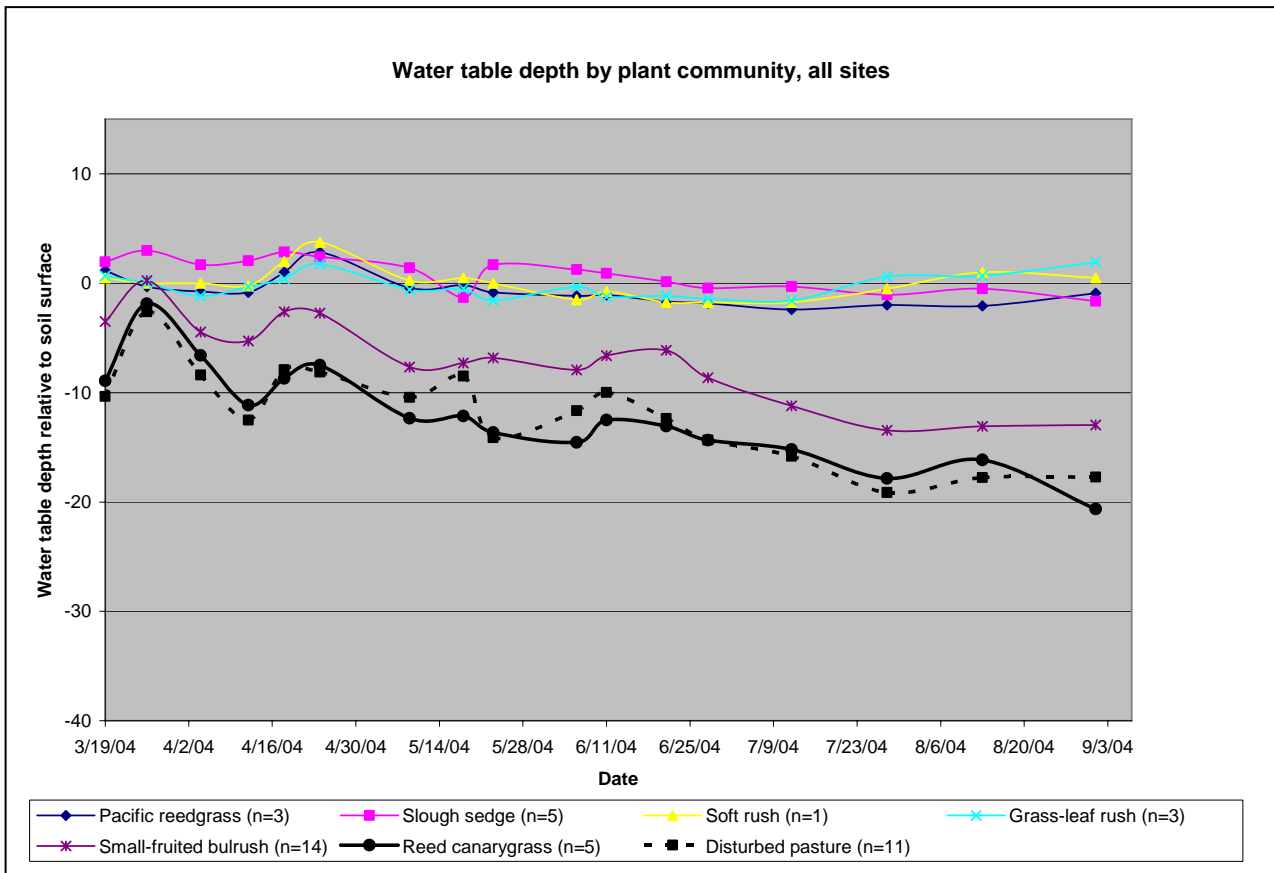
Figure 12. Water table dynamics by plant community (averaged across all study sites)
