Government Engineering

ODOT's Hidden Instruments Prove Strength in Numbers

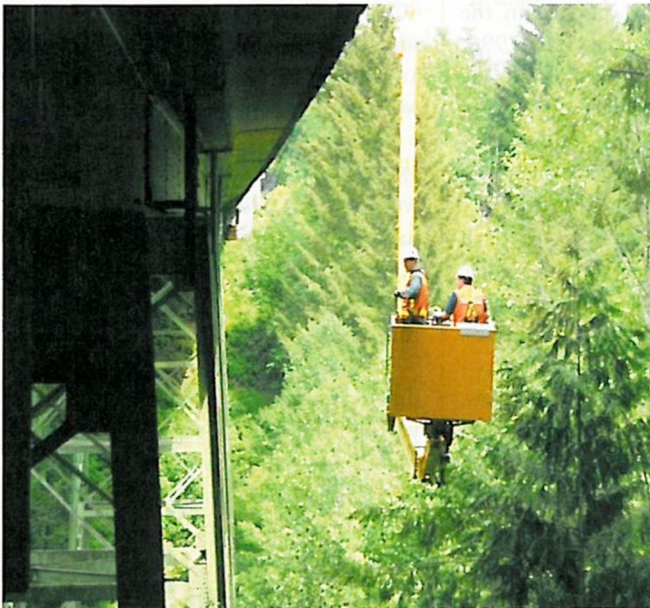
Steve Lovejoy, Senior Mechanical Engineer (left), and Nathan Leung, student intern, were suspended about 150 ft above the ground in a three-ft by three-ft bucket from which they placed postage-stamp size strain gauges.

Though computerized sensors would help him gather the information, this assignment was no desk job. Suspended about 150 ft above the ground in a three-ft by three-ft bucket, Lovejoy made his way under the bridges to strategically place postage-stamp size gauges on the structural supports that were unable to be accurately modeled. The strain gauges, a technology first developed in the 1880s, helped Lovejoy measure the stress that the bridges underwent as vehicles passed overhead.
